# Ohio Department of Natural Resources

July 18, 2024

Re: TRAQ assessment of pin oak in public ROW at 1100 Phillips Street Marietta, OH

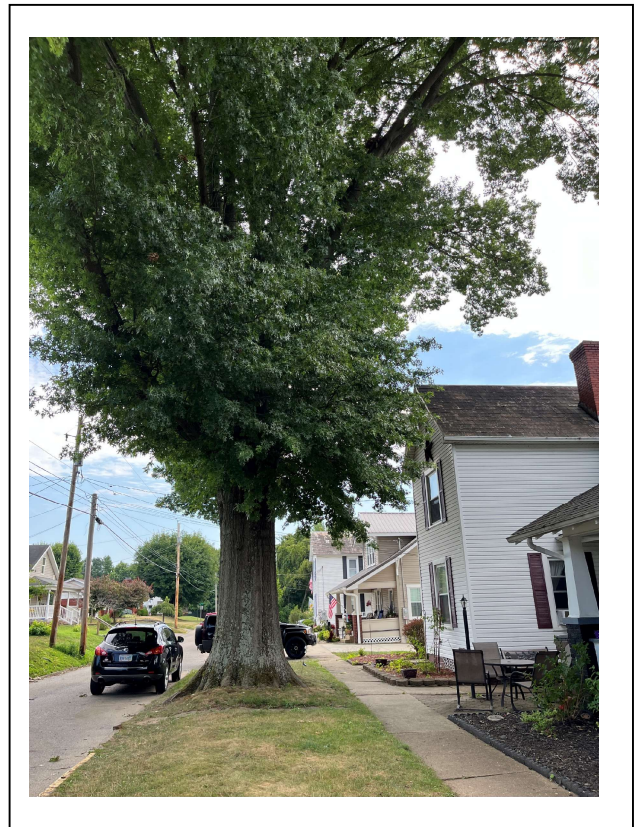
This tree is located in the Norwood neighborhood between the sidewalk and the curb. A primary electric wire runs to the north side of the tree. The tree's DBH is approximately 53 inches. The tree exhibits a very uniform and nicely flared root crown with no blemishes. The trunk is very well tapered with what foresters call, a "low center of gravity". The crown appears very healthy & balanced. The tree has been pruned periodically by the city and by electric contractors for clearance over the house and away from utility lines. **All** of the visible wounds show exceptional callus aka as wound wood. In layman's terms, the tree had the vigor to efficiently cover off the pruning wounds which protects the tree and makes it stronger over time.

An old wound was observed on a branch facing the house that we were told may be the result of an old lightning strike. From our ground inspection, this is plausible. The wound is flanked on both sides by generous wound wood that appears healthy. This tells us that the wound is old and that the tree has been working to compartmentalize it over many years.

Based on the track level two basic assessment that was done, this tree presents a moderate risk over the next year. Conditions of concern are the tree's size and location. The targets are the street and the homes and the people who frequent the area.

**While this tree appears healthy and structurally sound, I would recommend that that tree be added to the City's annual inspection list so that annual TRAs may be conducted. I would also recommend that the tree be pruned by an ISA Certified Arborist at the time when the maple nearby will be removed. Conducting clearance and reduction pruning of the branches that are stretching over the house shows goodwill towards the property owner and renter who do not like the tree. This will also be an opportunity for the ISA Certified Arborist to scan the tree Canopy for defects that are not visible from the ground.**

Lastly, due to this tree's proximity to primary AEP utility wires and the City's positive and long standing relationship with AEP, **future work could and should be coordinating with AEP** to save city dollars and to ensure the protection of the utility wires.
